Summary of Errors Related to Information Technology (IT) n=236

Author: Megan Rowley

This chapter covers transfusion adverse events that relate to laboratory information management systems (LIMS) as well as other information technology (IT) systems and related equipment used in the delivery of hospital transfusion services.

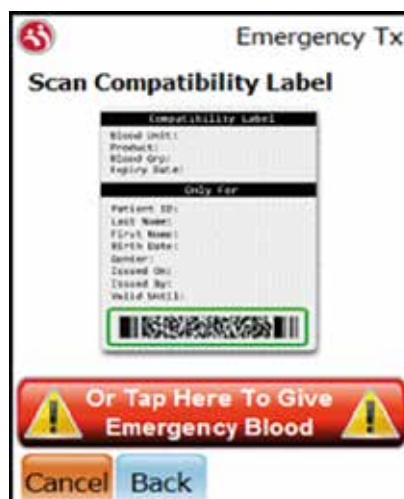
When the emergency option is chosen, after scanning the patient's identification band, the user encounters the following screen:

At this juncture the screen asks the user to either

- (a) scan the compatibility label which is attached to the units or
- (b) **'Or Tap Here To Give Emergency Blood'** if using the **emergency O Rh D-negative blood** which of course does not have a compatibility label. When this second option is chosen, the built in 'right blood right patient' safety checks are quite correctly bypassed by the system.

Between February and October 2014 a total of 273 units (average of 30 units/month) were transfused using the wrong option whereby the 'right blood right patients' safety checks were bypassed in error. The user had not scanned the compatibility label as they should have, but instead had chosen the **'Or Tap Here To Give Emergency Blood'** option even though they were not using the emergency O D-negative. A total of 105 staff were involved.

An incident report was raised on each occasion and the member of staff involved was contacted by email. A one-to-one retraining session was conducted, where the potential gravity of their error was reinforced. There were no repeat offenders identified. The message is beginning to get through, since the numbers for November and December 2014 are encouraging. Only 2 units were transfused using the incorrect option in November, and 13 units in December. This error occurs both when only 1-2 units are given and when multiple units are given i.e. major haemorrhage.

The company (Haemonetics) has acknowledged this potential weak link in an otherwise very safe system, and has made assurances that it will be rectified in the next software version due in June 2015. In the meantime we intend to continue with our present policy of raising an incident report and conducting one-to-ones with the individuals concerned, every time it happens.

- Root cause analysis of the incident above
- Review other sites to determine whether this issue is occurring elsewhere
- Sent an advisory letter to all customers reminding them of correct use and confirmation of the next release of software which will include enhancements to the Emergency Blood protocol
